Muirfield Village Condos
1265 S. Aaron
Mesa, AZ

Summary Report of Damages Caused by UCI

Date: 8-15-22

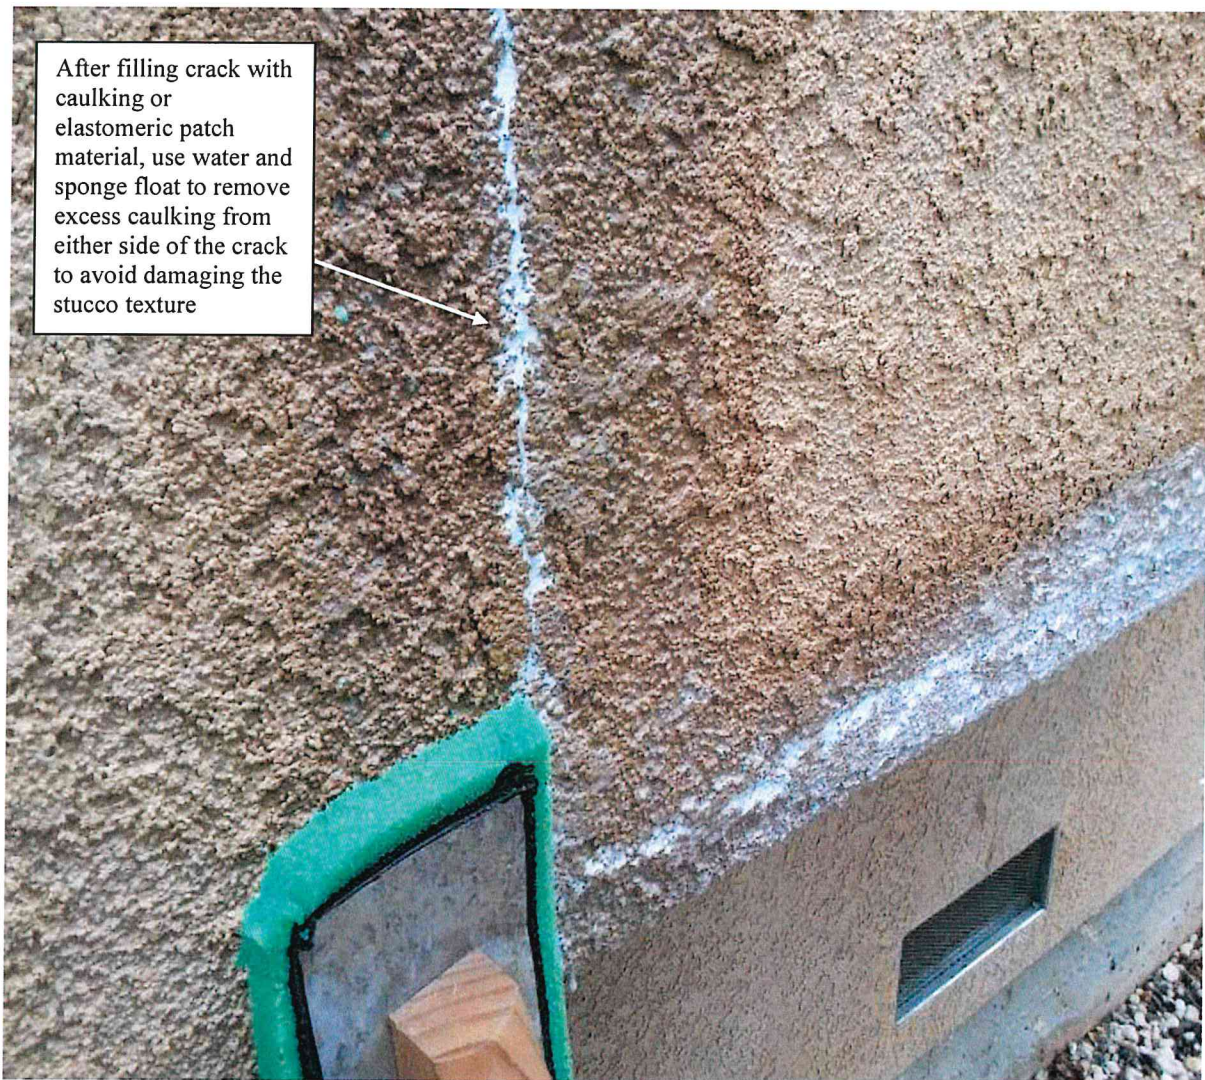
PHOTO #13

acrylic latex caulking product. Rather, UCI use a non-textured siliconized acrylic latex caulking product called "White Lightning" to fill the cracks. See PHOTO 12. When using such a caulking product such as White Lightning, the caulk must be applied into the crack and then blended/sponged/wiped down to: (1) be forced into the crack to fully fill the void that the crack creates in the stucco's surface; and to avoid damaging/altering the existing texture of the stucco on each side of the crack. See PHOTO 13. UCI however, instead, applied the White Lightning caulk over each and every crack and then did not blend the material into the crack or remove the material from each side of the crack by blending/sponging/or wiping it off. The result was a buildup on each side of every crack of the caulking material that: (1) damaged the stucco's texture on each side of the crack; and (2) caused each side of every crack to now be built up or higher than the stucco finish that it was applied over.
